PROFILE OF PROPERTY (continued)inued)
PICTURES OF SUBJECT

BUILDING DATA

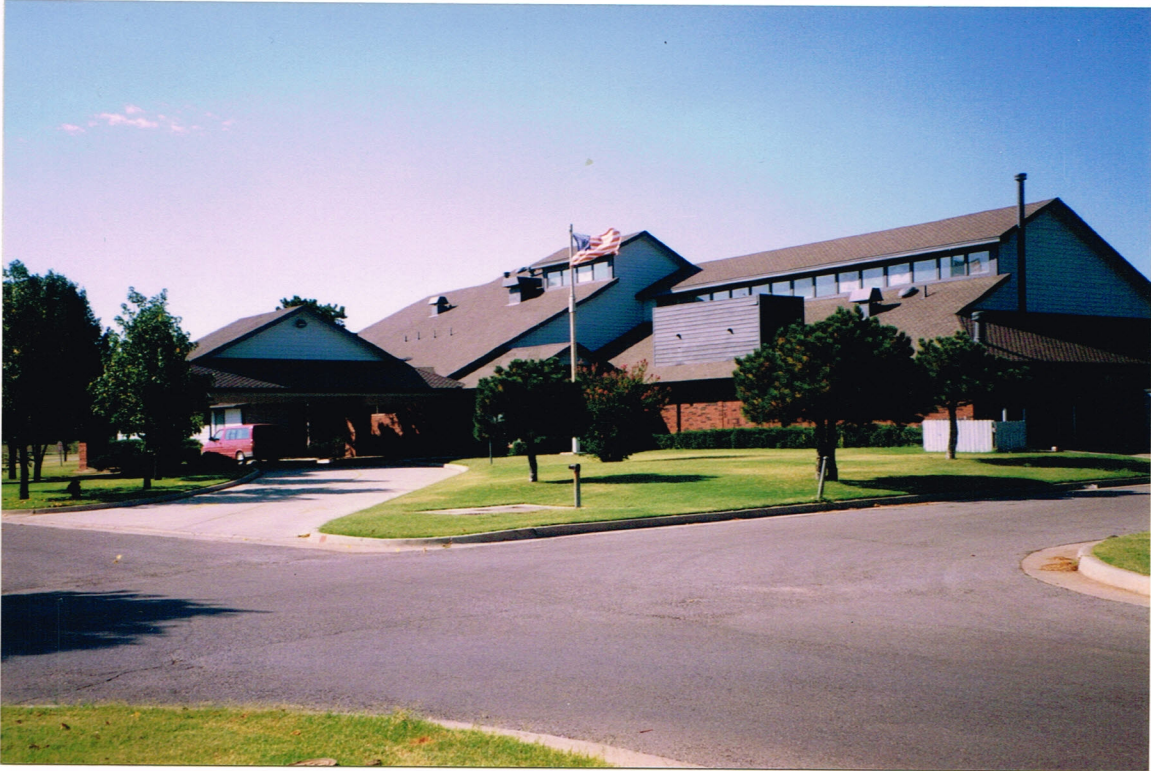
Subject Property - Clubhouse, front view

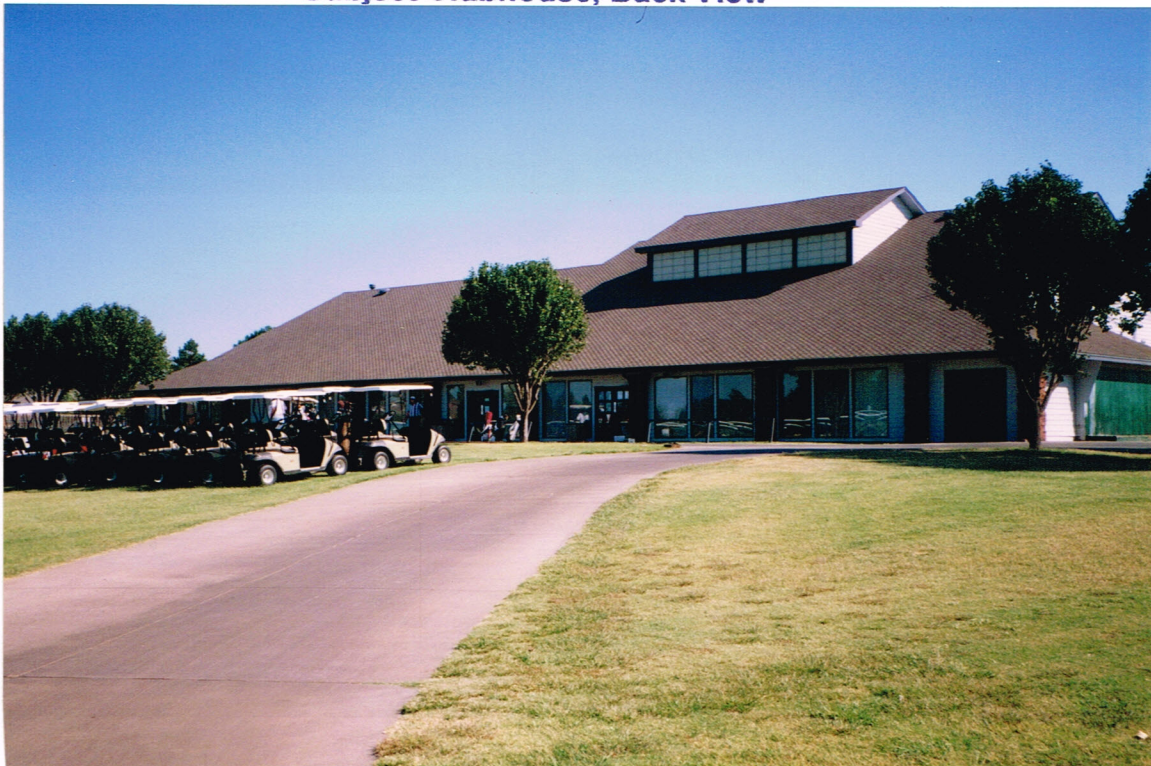
Subject Clubhouse, Back View

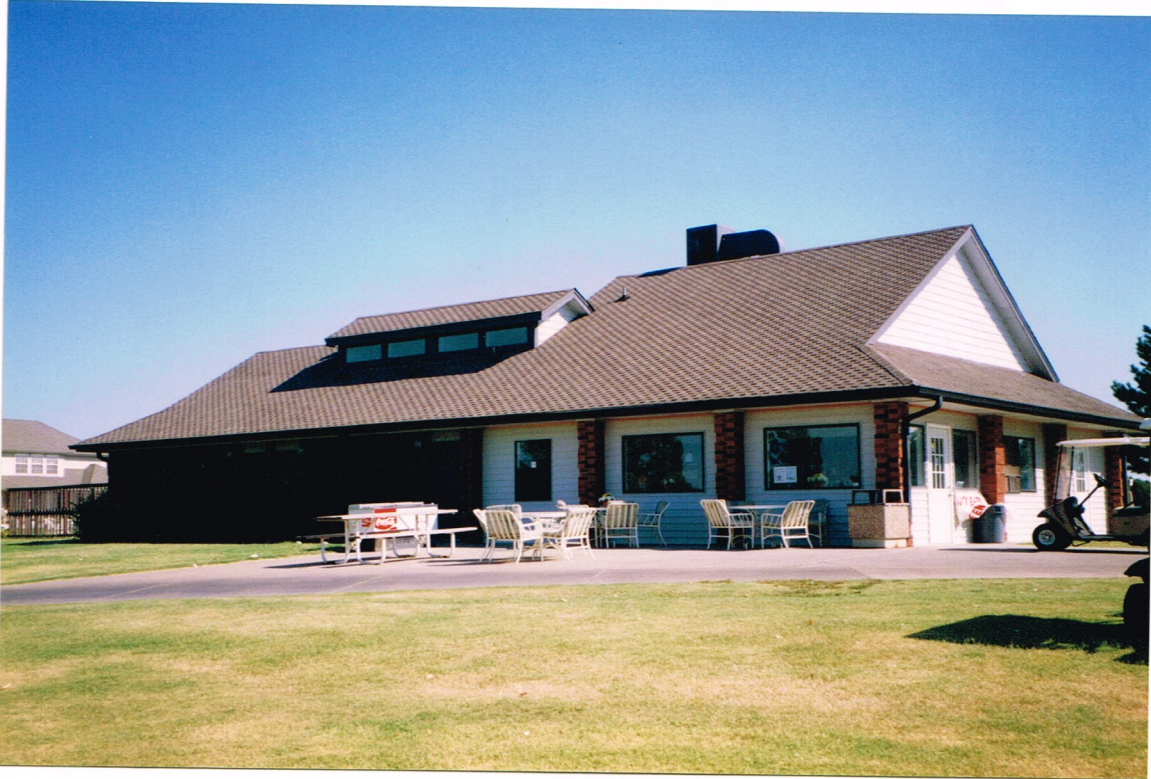
Snack Bar - Golf Course Side

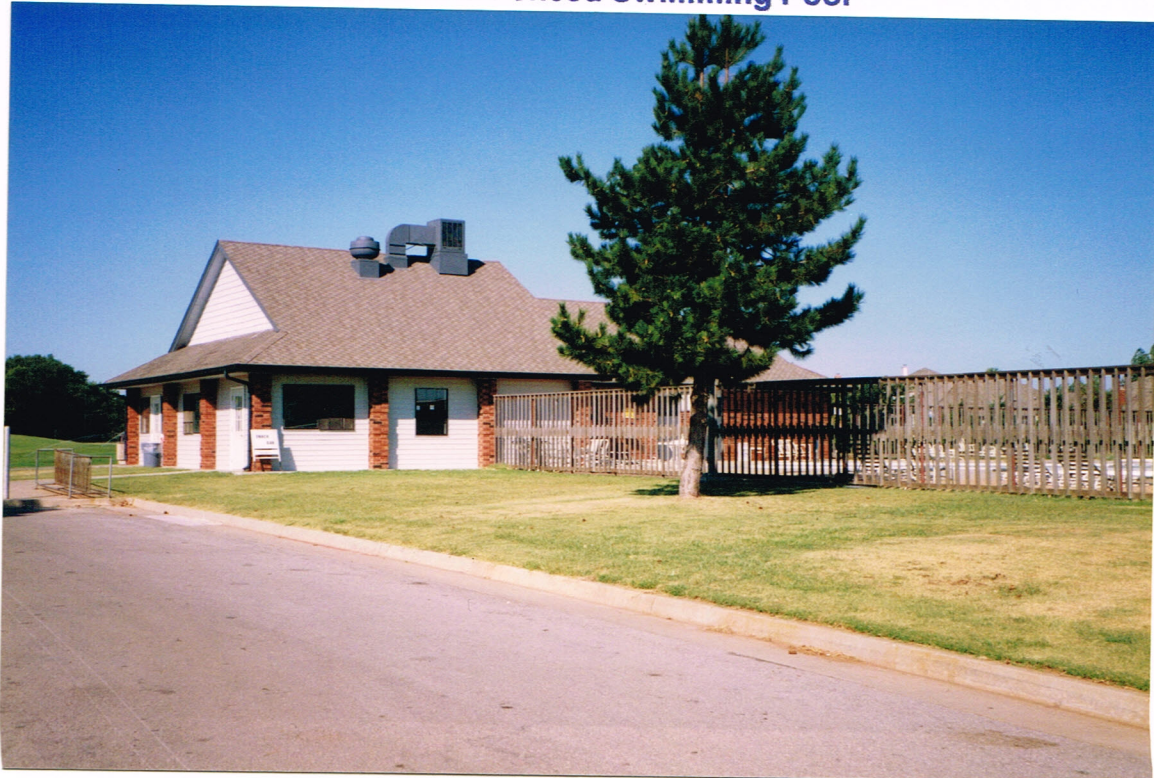
Snack Bar and Fenced Swimming Pool

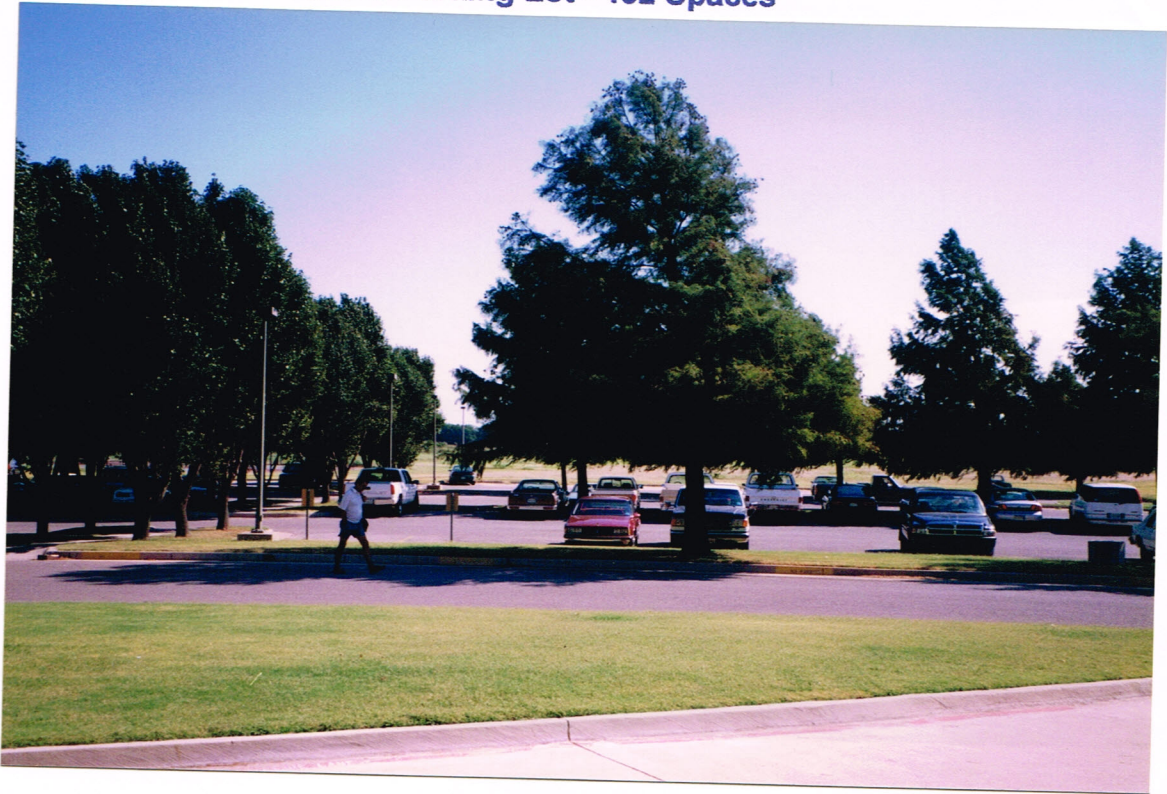
Guest Parking Lot - 132 Spaces

Subject has adequate parking of 132 guest parking spaces with areas for another 30 spaces when necessary.

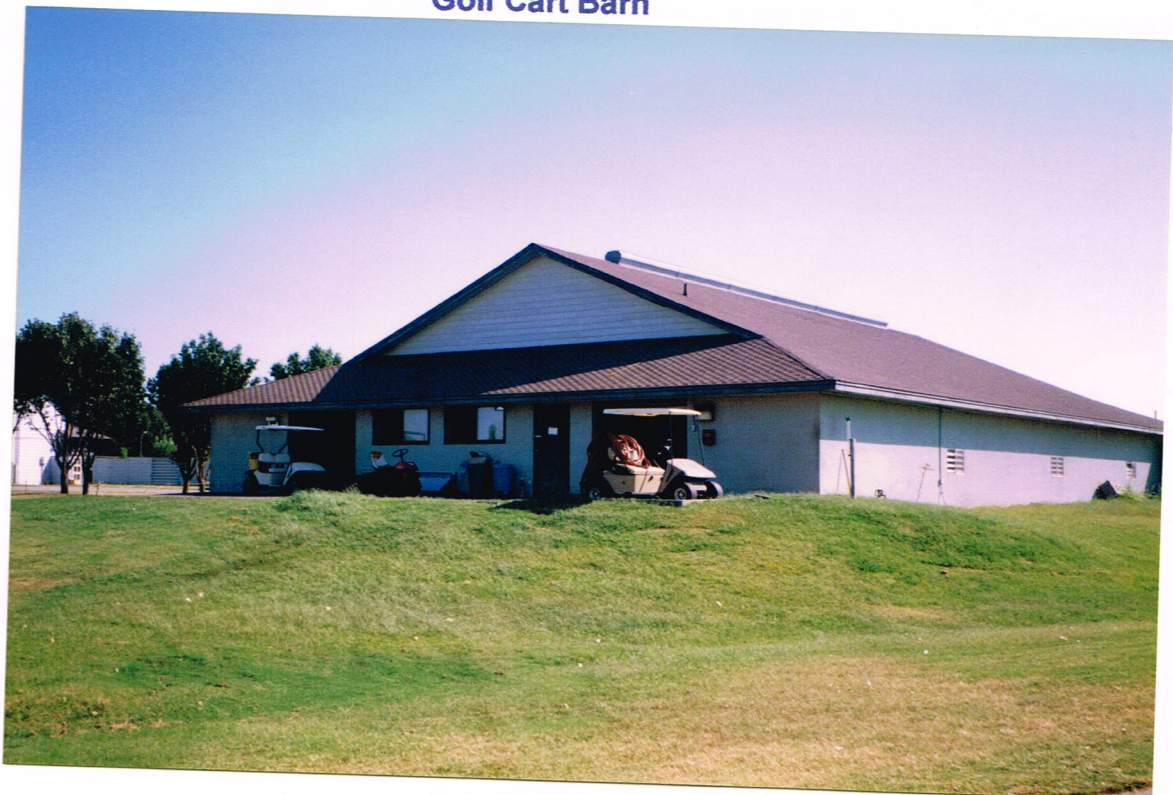
Golf Cart Barn

A concrete block building with composition 5/12 pitched roof with approximately 75 high voltage connections for charging electric golf carts.

Subject property is in good condition, inside and out. The only deferred maintenance is possibly a small item, painting of the cart barn.

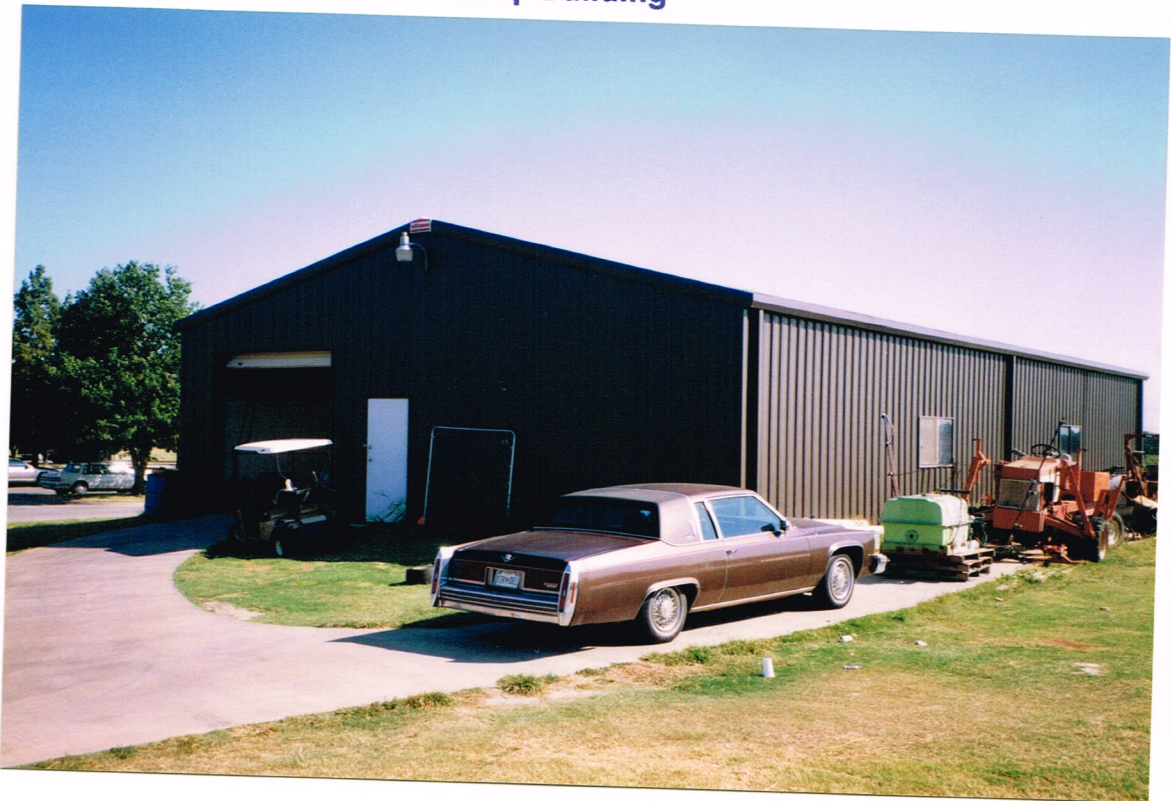
Shop Building

An all steel building with unfinished walls - strong electrical capacity.

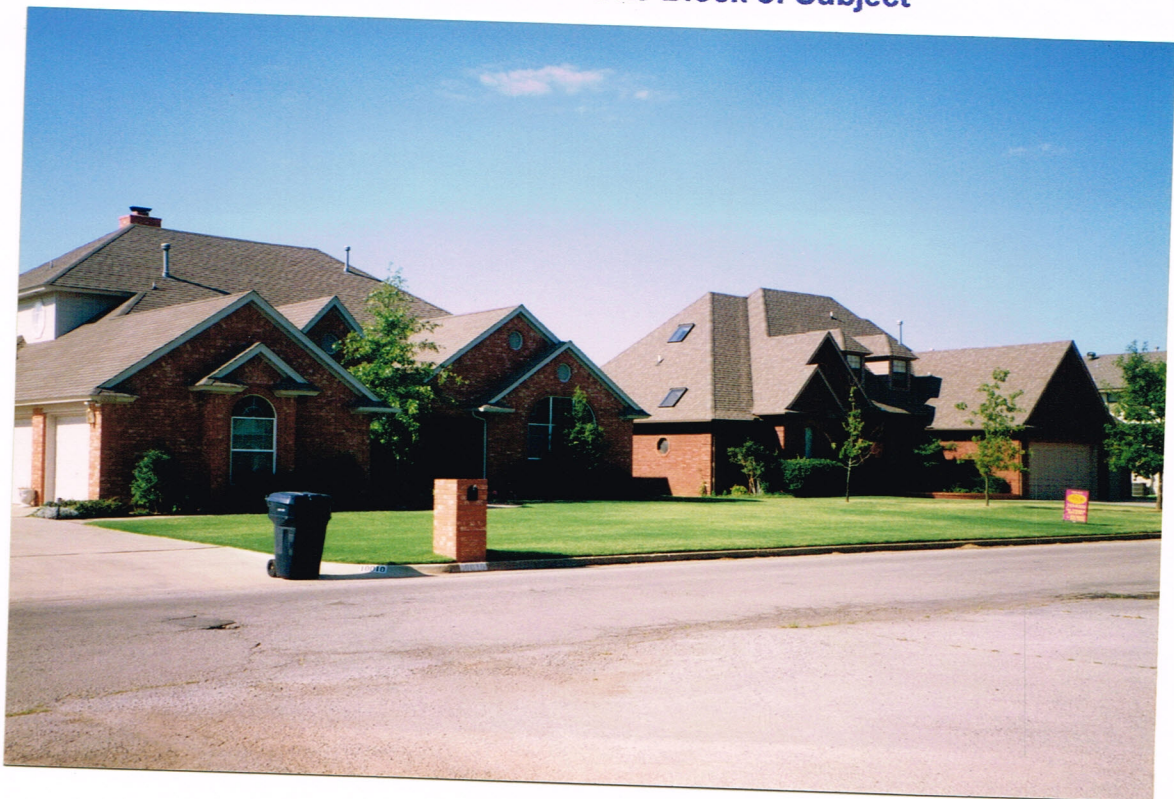
Typical Homes Within One Block of Subject
