## RESIDENTIAL INSPECTION

2700 W Grand Ave  
Chickasha OK 73018

Leman & Louise Spoon Trust  
MARCH 29, 2021

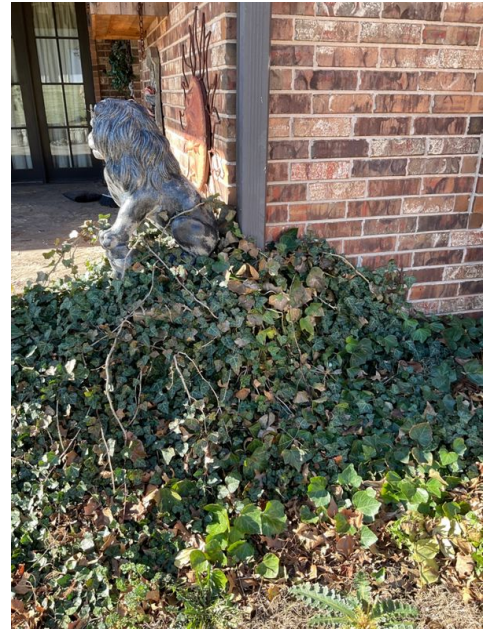
2.2.1 Vegetation, Grading, Drainage & Retaining Walls

**VEGETATION IN CONTACT WITH SIDING**

Can result in damage to siding and/or insect intrusion. Trim all vegetation to maintain 10-12" air space between vegetation and dwelling.

Ivy

Recommendation

Contact a handyman or DIY project

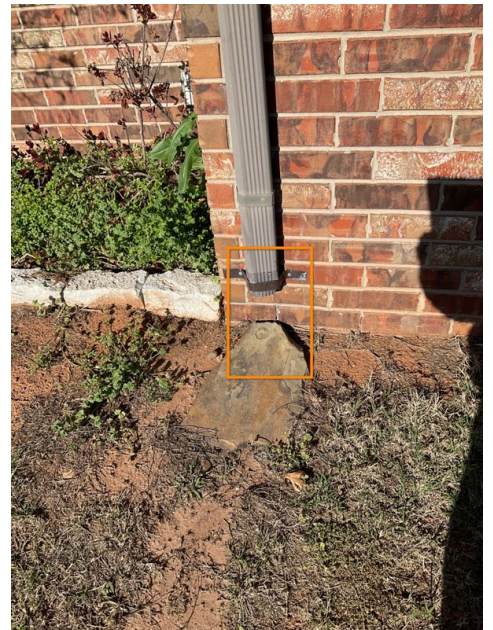
### 2.5.1 Downspouts

#### **BOTTOM ELBOW-MISSING**

This directs water right against foundation. Over time this may contribute to settling and a host of other structural issues. Have elbow re-installed to divert water away from structure.

East

Recommendation

Contact a qualified gutter contractor

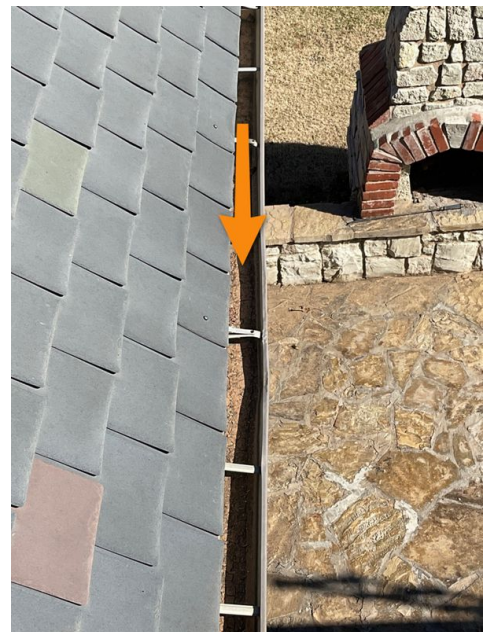
3.1.1 Roof Drainage Systems

**DEBRIS**

Debris has accumulated in the gutters. Recommend cleaning to facilitate water flow.

Recommendation

Contact a qualified roofing professional.

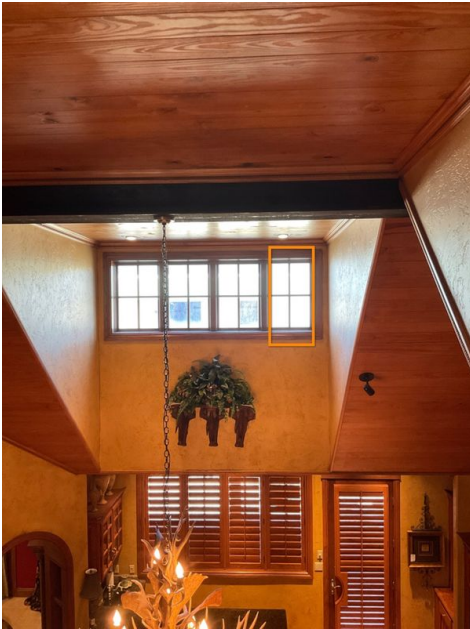
6.2.1 Windows

**FAILED SEAL**

Observed condensation between the window panes, which indicates a failed seal. Recommend qualified window contractor evaluate & replace.

Recommendation

Contact a qualified window repair/installation contractor.

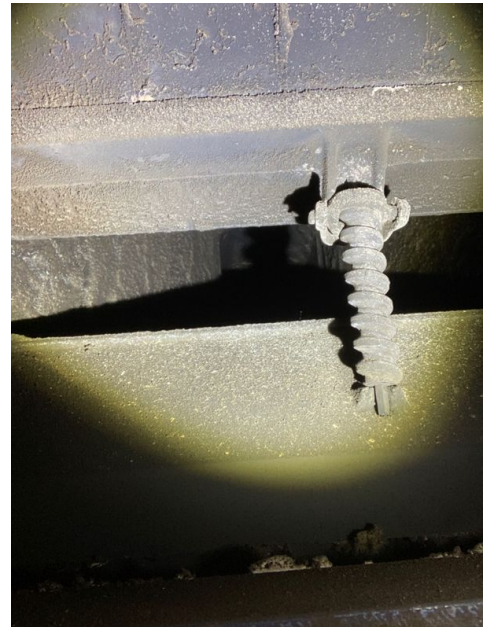
### 6.8.1 Fireplace

#### **CHIMNEY-IN NEED OF CLEANING**

Build up in chimney can hinder smoke evacuation and may also cause a fire danger. Have cleaned prior to use.

Safety Hazard

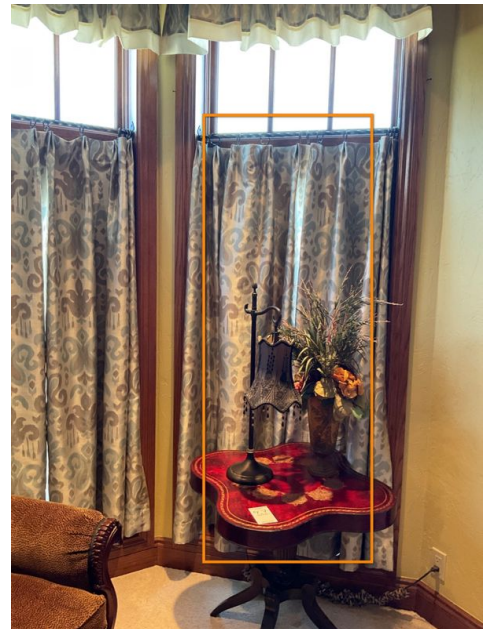
### 9.3.1 Windows

#### **DAMAGED**

One or more windows appears to have general damage, but are operational. Recommend a window professional clean, lubricate & adjust as necessary.

Recommendation

Contact a qualified window repair/installation contractor.

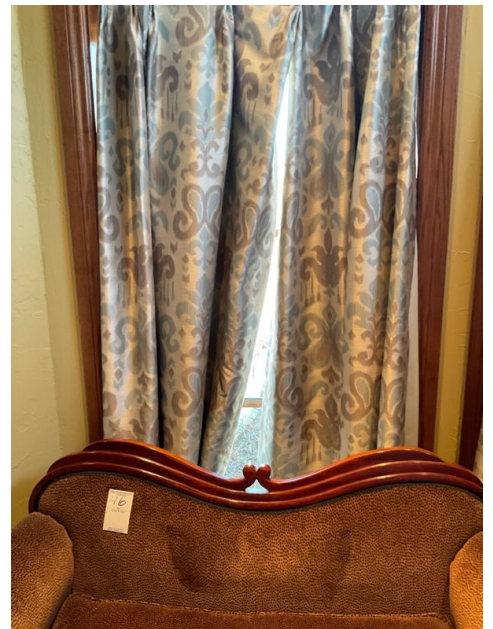
9.3.2 Windows

**DOES NOT OPEN**

May impede egress in an emergency situation. Have repaired/replaced.

Recommendation

Contact a qualified window repair/installation contractor.

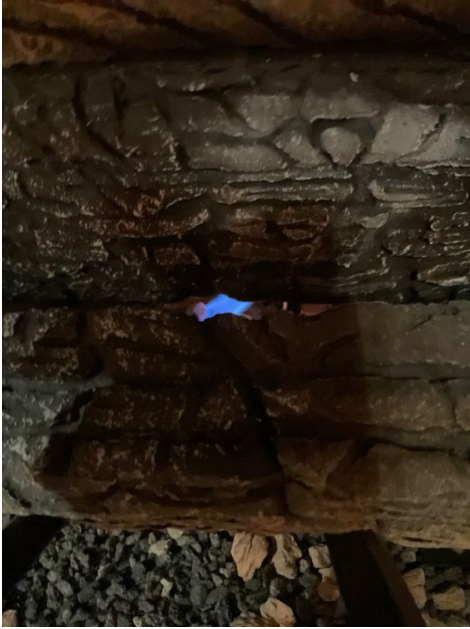
### 15.8.1 Fireplace

#### **BURNER WILL NOT LIGHT**

Pilot light is operable. Burner will not light.

Recommendation

Contact a qualified fireplace contractor.

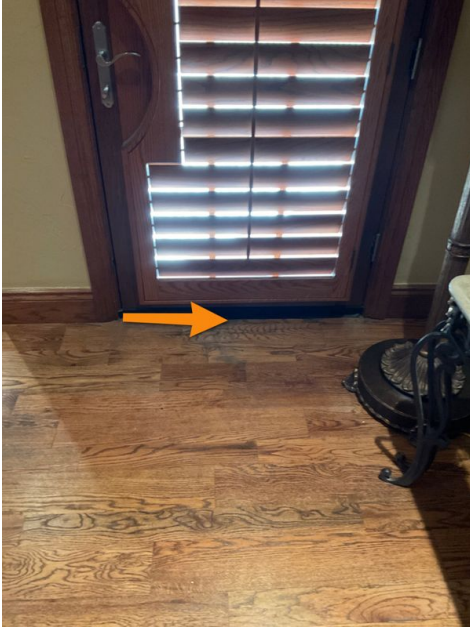
Door sticks and is tough to open. Recommend sanding down offending sides.

Recommendation

Contact a qualified handyman.

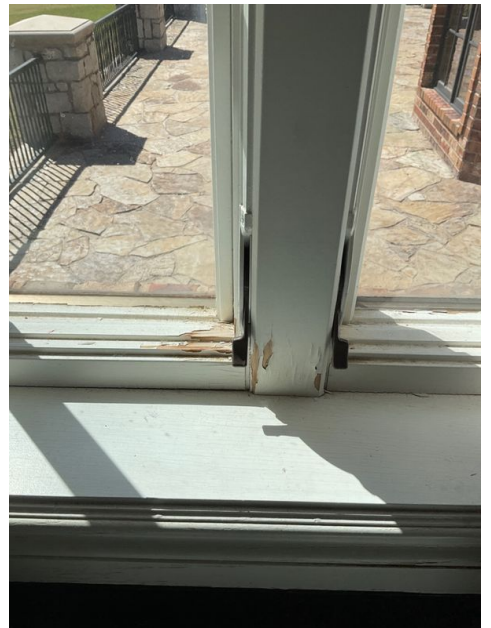
**FRAME/SILL-EVIDENCE OF MOISTURE DAMAGE**

Monitor for further moisture. If any is noted, have evaluated and corrected.

Recommendation

Recommend monitoring.

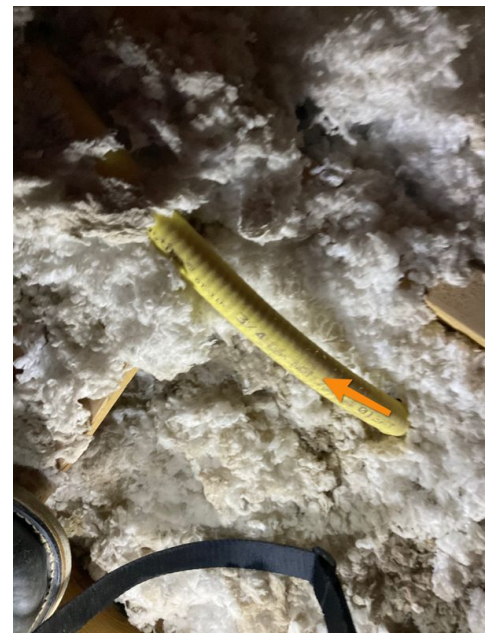
The manufacturer of Corrugated Stainless Steel Tubing (yellow coated, flexible gas distribution line) has very specific bonding instructions. Proper bonding is required (per the manufacturer) to help avoid the risk of damage during lightening storms.

The Oklahoma Construction Industries Board does not allow Home Inspectors to verify bonding on CSST. Recommend having a licensed electrician to verify that CSST gas distribution line is properly bonded.

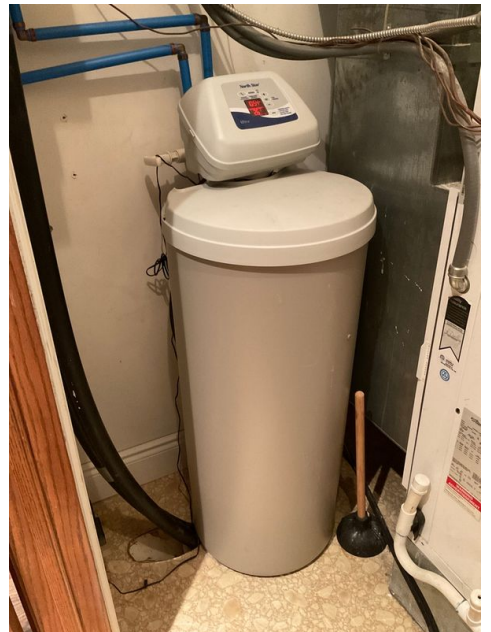
**WATER SOFTENER-NOT INSPECTED**

Outside the scope of this inspection
